## **CONSERVATION AND MANAGEMENT PLAN**

**2012 - 2019**

**Wesleyan Cemetery, Walkerville**

**JULY 2012**

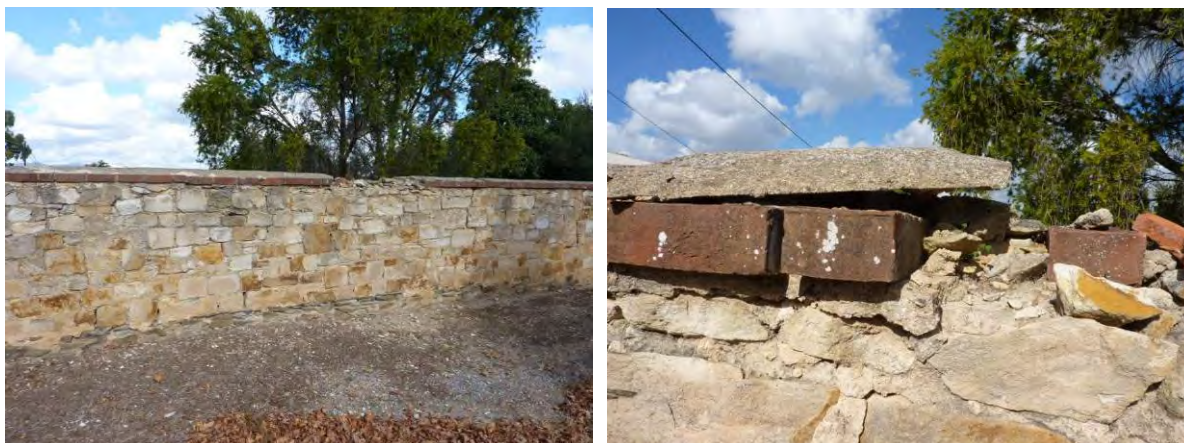
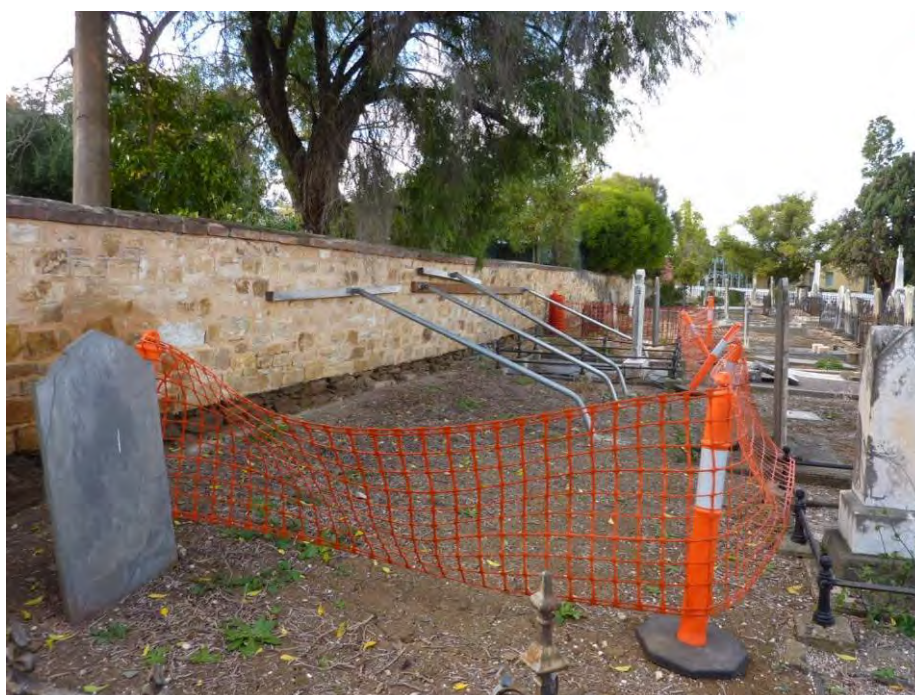
- The original lime mortar coping over the bricks is intact in some places, but is seriously deteriorated, causing water penetration. The coping is missing in places, and has been replaced by solid concrete coping in the south east section adjacent to the school block.
- Sections of the walls have been repointed at various times with hard cement mortar which is now creating some problems of rising damp and fretting of early lime mortar.
- The pointing to the bluestone base course of the north west wall has fretted and is in poor condition.
- There is serious deterioration of the masonry, and the brick pillar, at the Gawler Terrace end of the northwest wall.
- The ground level on the adjacent property to the north west has been built up against the wall, breaching the original bitumen damp proof course of the north west wall.

**Views of Boundary Stone Walls**

Works to the walls should maintain their original form, construction and materials as far as possible as these are highly significant structures which form the boundaries of the Cemetery

acre. Repairs currently required, particularly to the central section of the northwest wall, should be as conservative as possible, without compromising public safety.

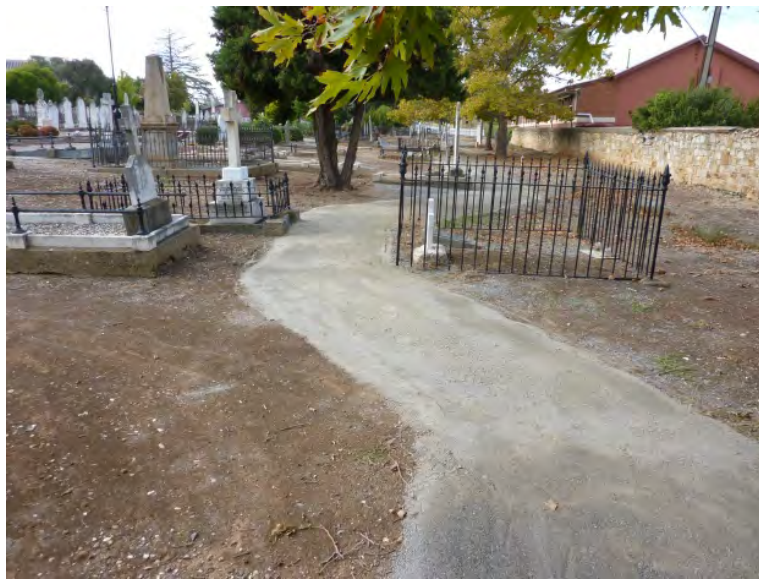
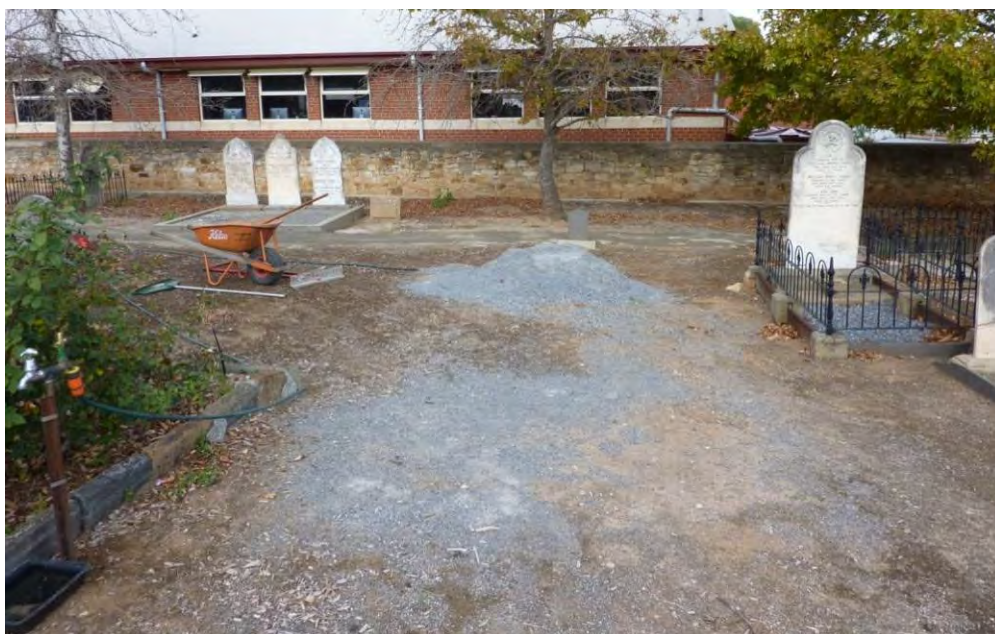
**Views of new grey dolomite path and storage heap**

Materials for use in the cemetery should be stored elsewhere until needed and used promptly, assuming normal conditions.

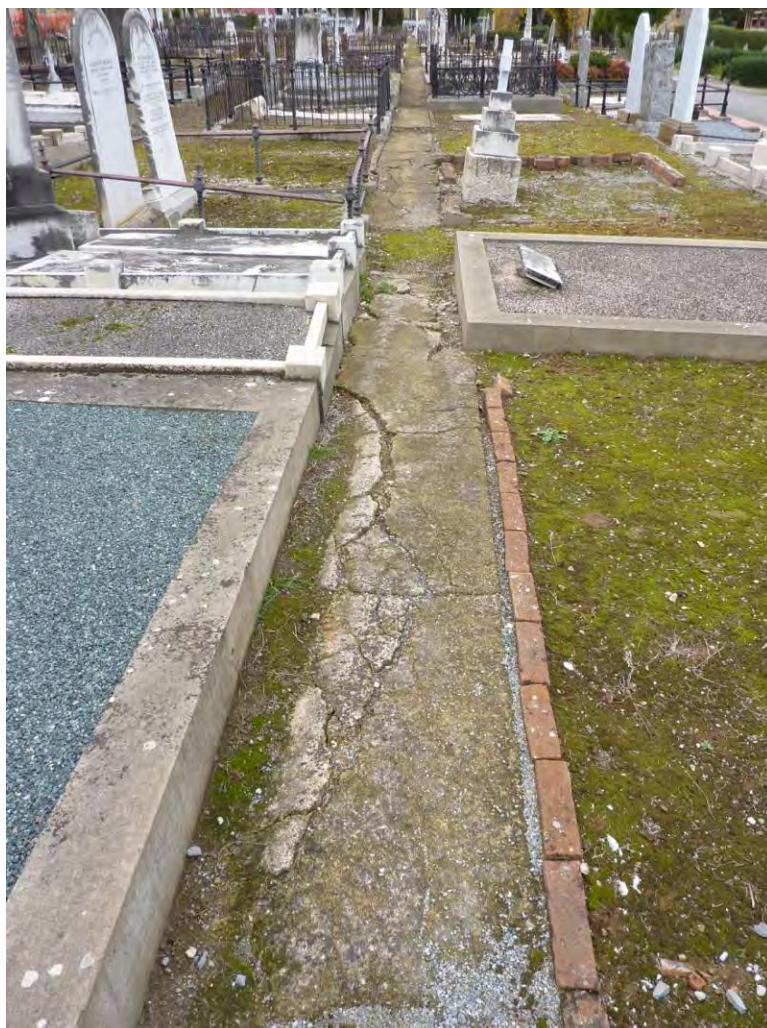
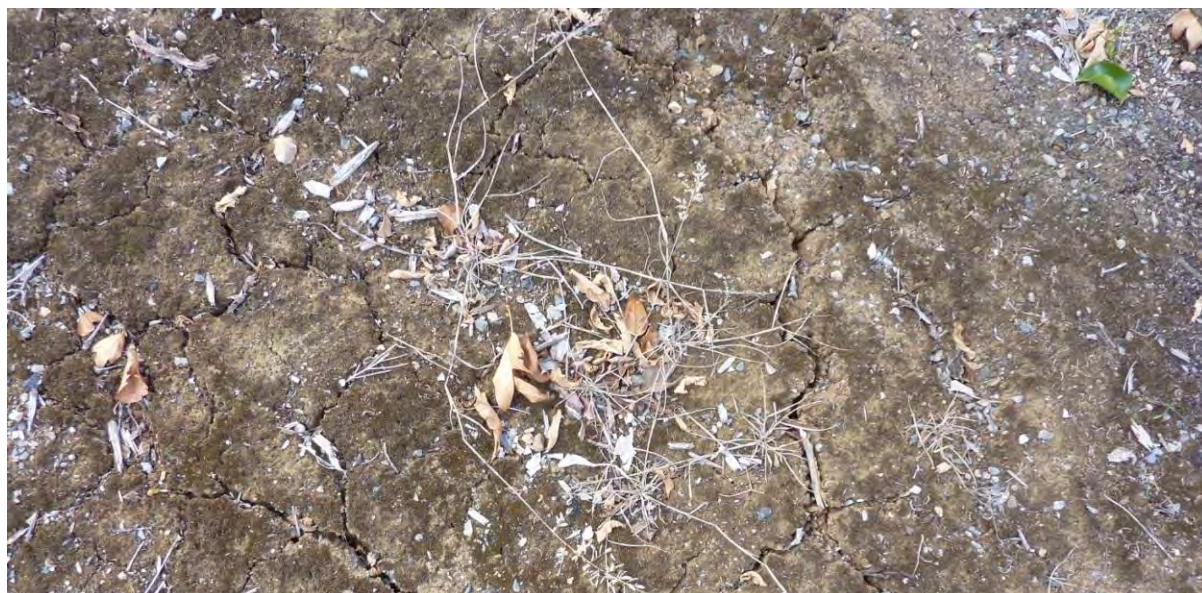
**Views of early paths and natural ground colour**

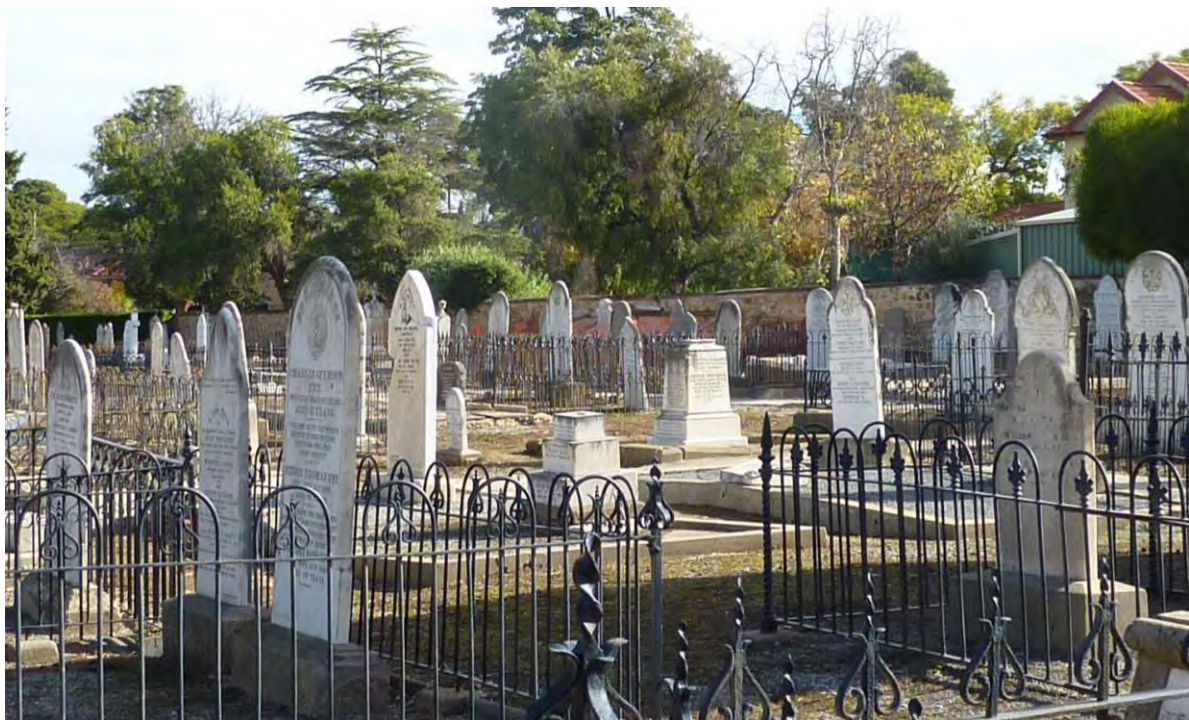
Early headstones reflect various forms of deterioration including loss of lettering, lichen and dirt encrustation. Many early headstones are broken, and some are almost obscured by soil.

### General view of marble headstones and fencing

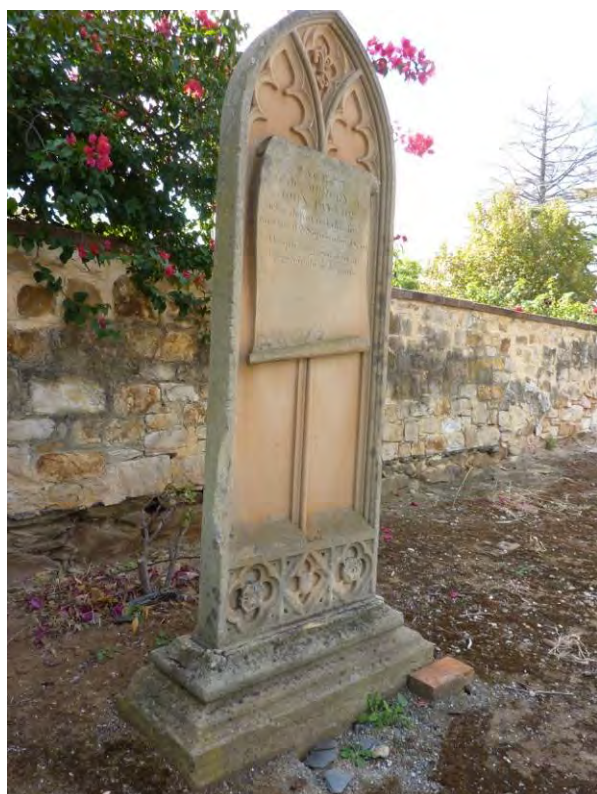
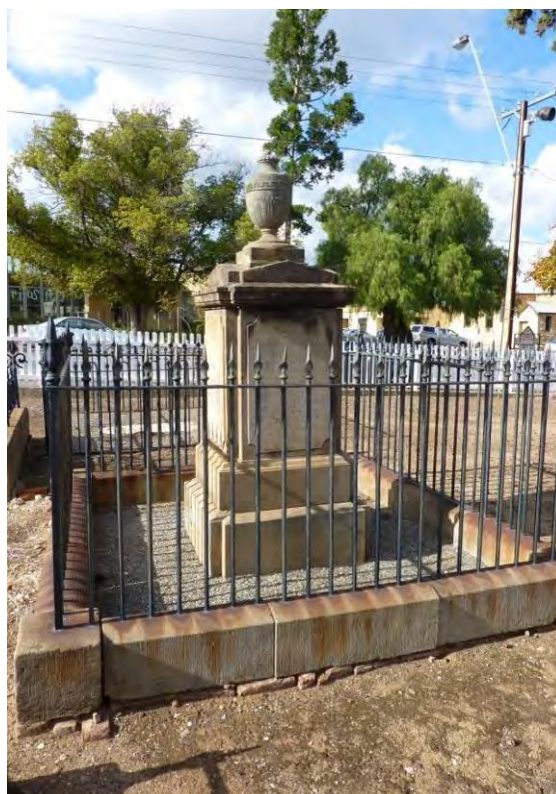
### Examples of sandstone headstones and monuments

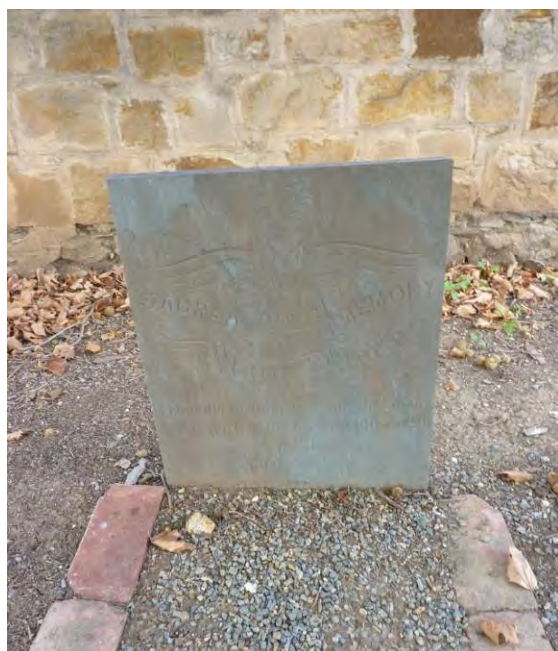
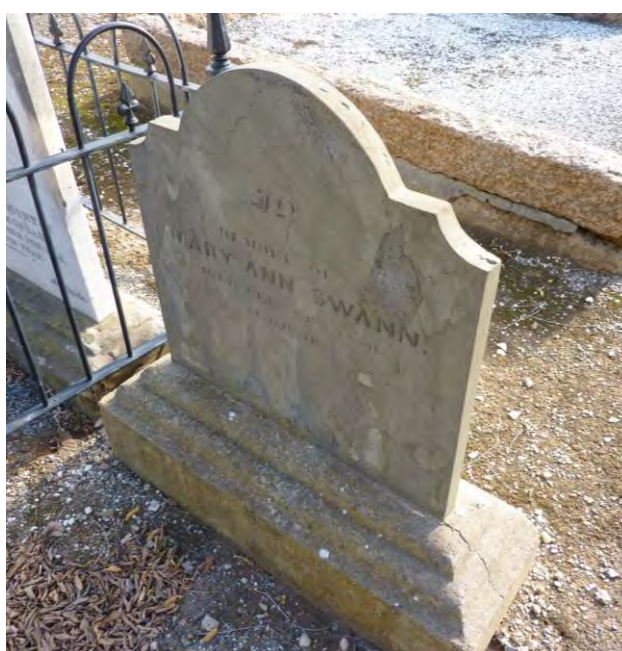
### Examples of small slate headstones

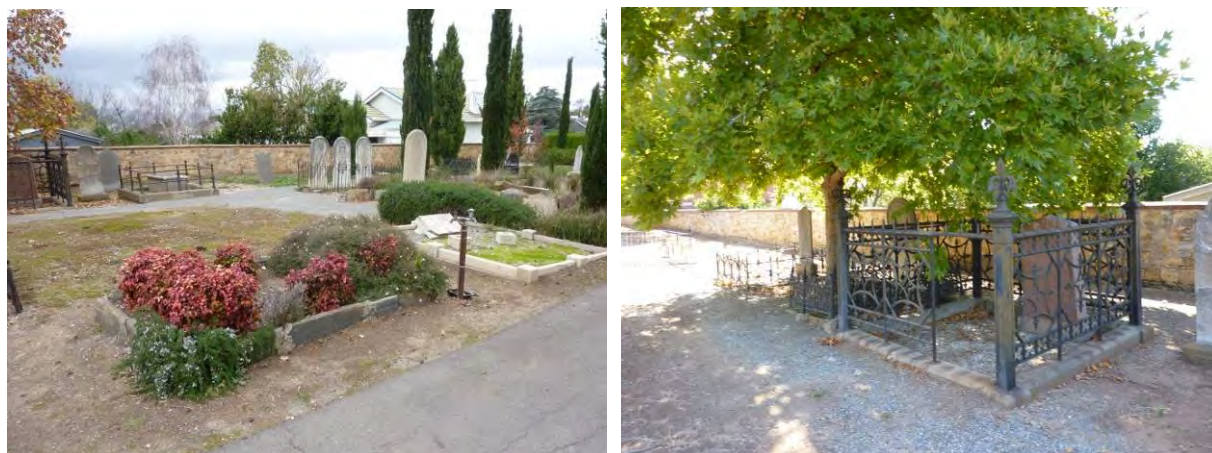
Generally, the landscaping has created a pleasant environment for visitors to the Cemetery. While not all elements are traditional, the general character of the Cemetery is enhanced by the garden beds, trees, wisteria arbour and seating.

**Garden beds, trees and landscaping**

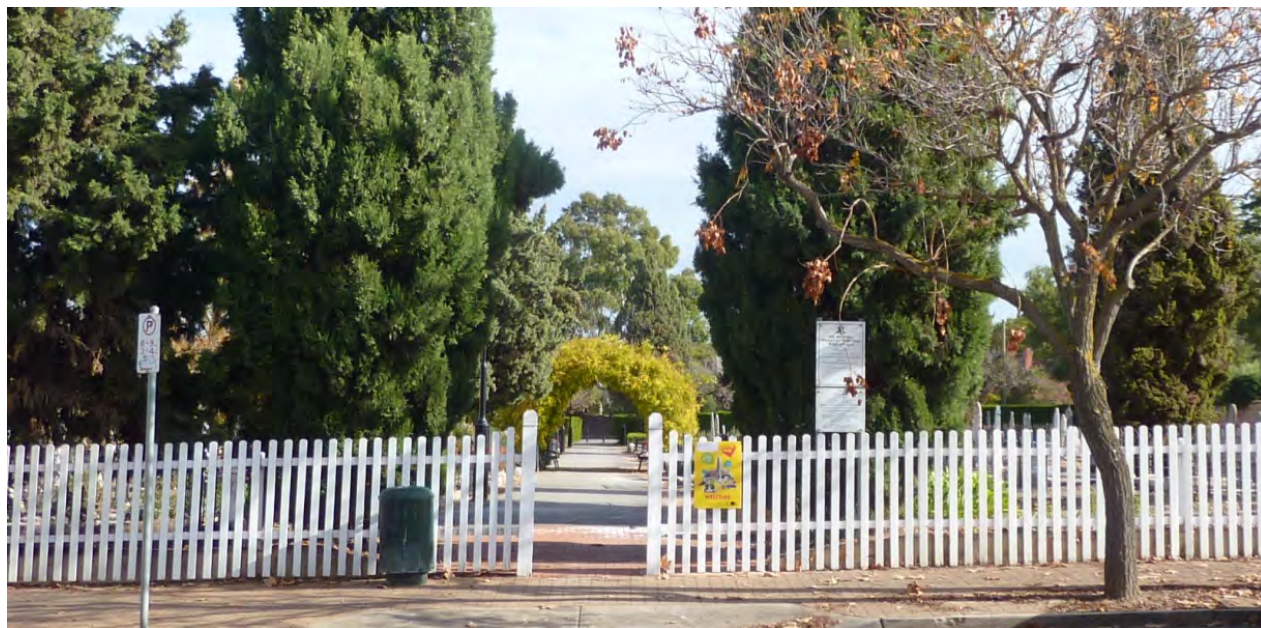
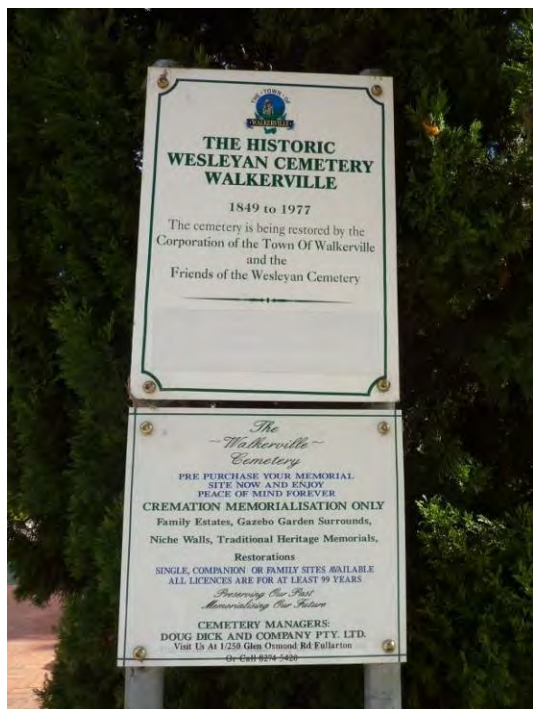
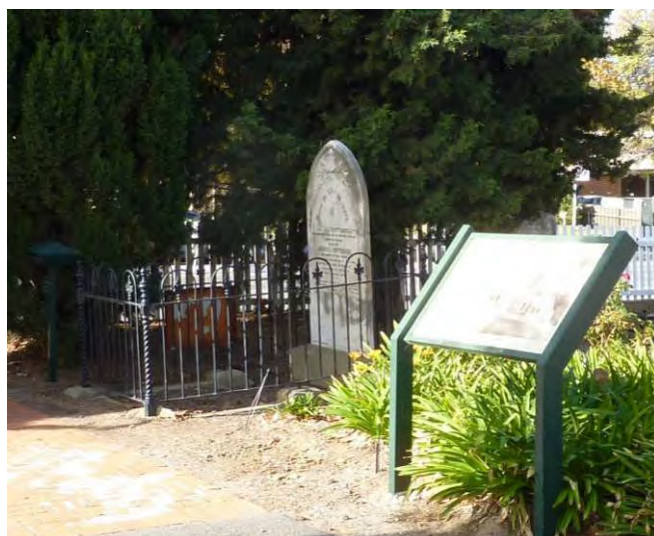
Cemetery sign on Smith Street 5 metres north of entrance gate, interpretation sign inside gate along central path.

### Smith Street Entrance and Signs

The existing signs are recent and in good condition. Existing entrance signs should be updated to reflect that the site is Council owned and provide details to visitors to the Cemetery (with regard to staying on paths), and contact details for the Cemetery Manager.

The current signs and notices should be updated. It is recommended that minimal signs be added to those already present in the Cemetery as they can detract from the historic nature of the site.

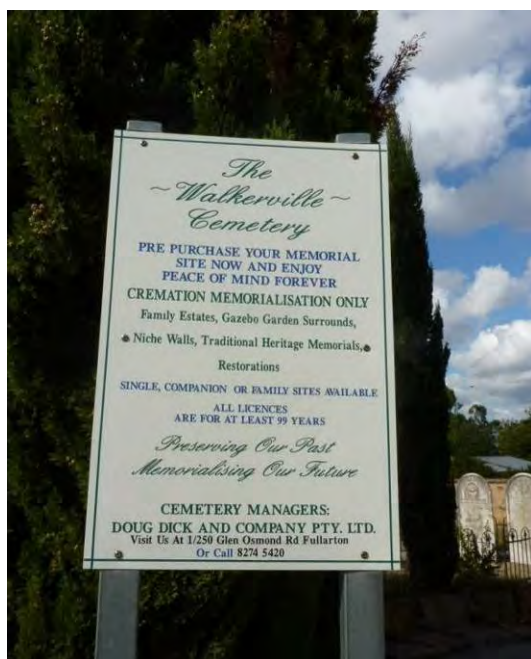
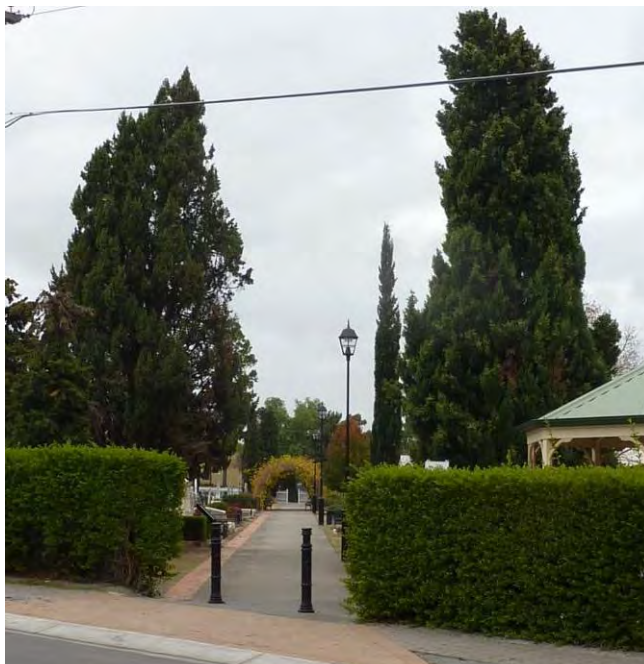
The main sign at this entrance is a new Cemetery sign with information about new inurnments. No historic information is included.

**Gawler Terrace Entrance and Sign**

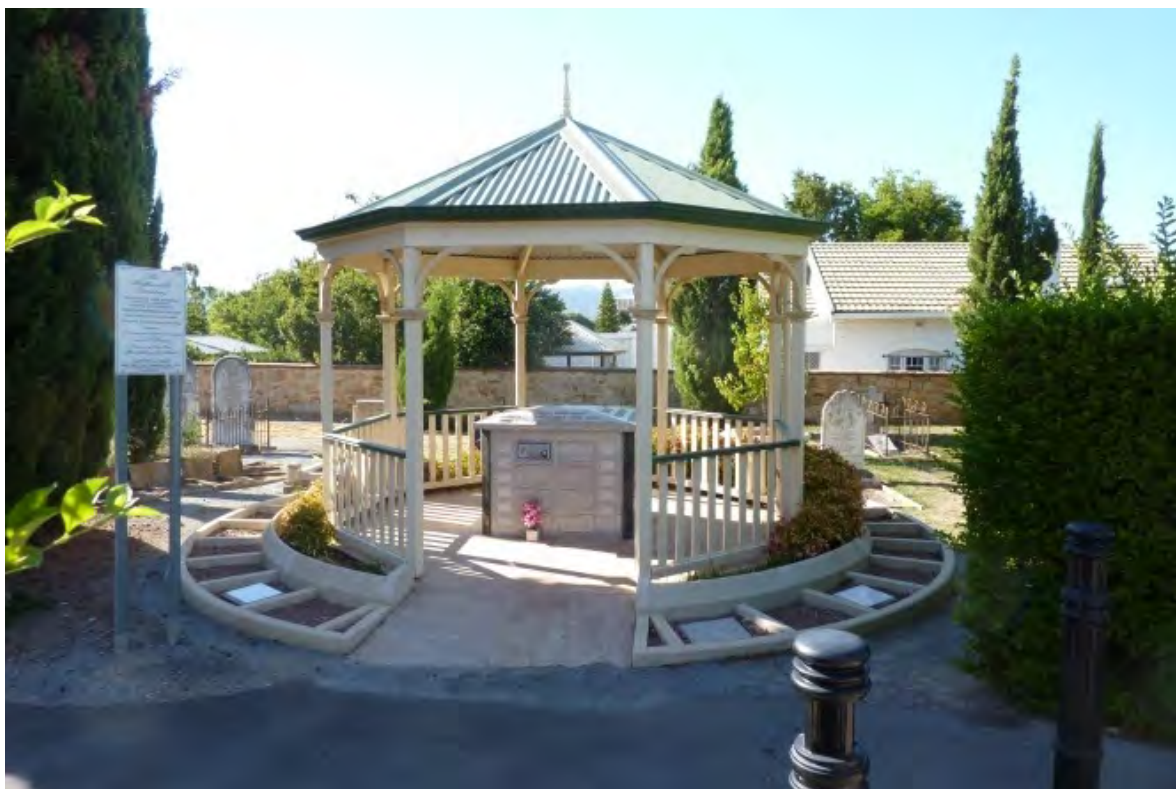
**Rotunda**

The heritage value of the Wesleyan Cemetery lies in its historic qualities and this section of the Cemetery does not reinforce or complement that established value.

Careful consideration should be given to the redesign and integration of this area with the rest of the site.
